# Manhole Inspection Summary

Manhole # S51E\_\_009MH

Insp Date: **5/13/08 8:31 AM**

**Location** Address: **rear 139 s linwood ave**

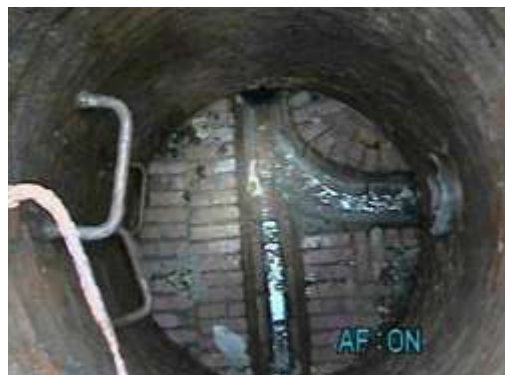
Top View

top view & steps

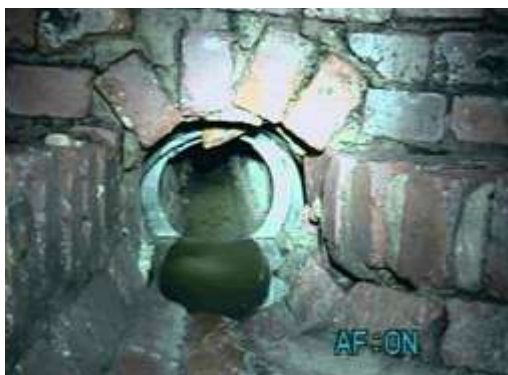
Defect 2

Condition: ☐ Sound ☒ **Cracked** ☐ Root Intrusion ☒ **Loose Brick** ☐ Deteriorated

Loose bricks in barrel and channel. Crack in barrel

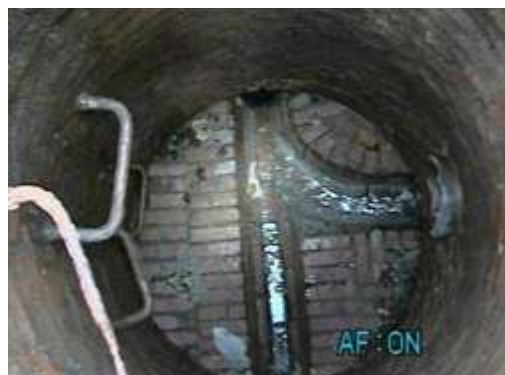
Defect 1

**Steps** Count: **4** Missing: **0** ☒ **Corroded**

steps

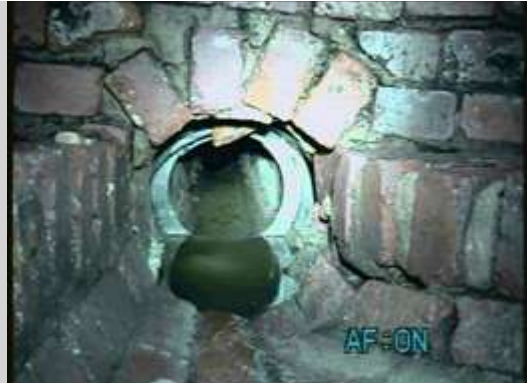
12 O'Clock Outflow

8 in. Circular Gravity Sewer  
Pipe Out @ 12 O'Clock

Invert Depth: **9.04** (ft.) Flow Characteristics: **Fast**

Infiltration: **None** Pipe Seal Cond: **Unknown**

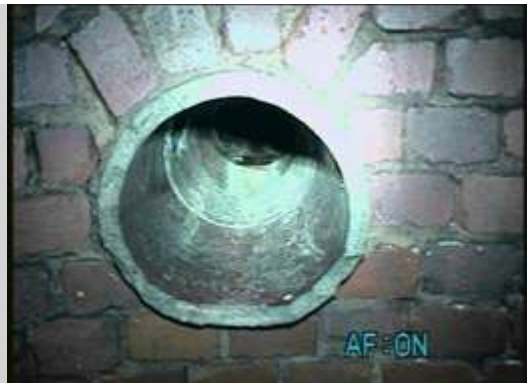
3 O'Clock Inflow

8 in. Circular Gravity Sewer  
Pipe In @ 3 O'Clock

Drop In @ 3 O'Clock

Drop: **Outside Direct**

Drop Condition: **Open**

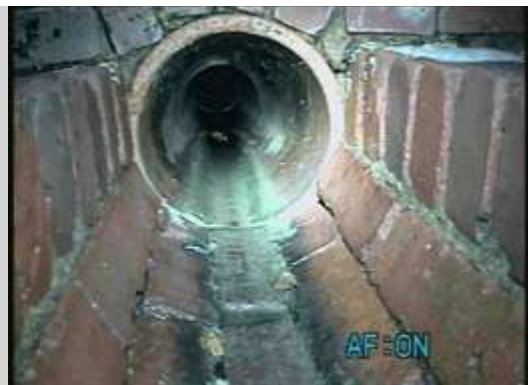
6 O'Clock Inflow

8 in. Circular Gravity Sewer  
Pipe In @ 6 O'Clock

Invert Depth: **8.95** (ft.) Flow Characteristics: **Fast**

Infiltration: **None** Pipe Seal Cond: **Unknown**
